VIBRATION TEST WITH ACCELERATION FOR PORTAL RADIATION MONITOR BASED ON SNI IEC 62244:2016

D. Intaningrum, I.D. Junianto, R.L. Tyas, dan M. Amin

Radiation portal monitor (RPM) due to the certification process should be tested according to SNI IEC 62244:2016. This standard required several tests to be applied such as mechanical shock that was conducted by vibration test. The requirement that should be complied with is no alarms or other changes happening during the process, the varying indications of the monitor are not more than 15%, and no damage to the monitor component. RPM was tested in operating conditions and was exposed to radiation sources. Radioactive sources are set 50 cm from the reference point. For frequency test, RPM was given harmonic load $0,5 g_n$ for 10 minutes with frequencies that increase gradually from 10 Hz to 150 Hz then decreases from 150 Hz to 10 Hz in each orthogonal direction (x, y , and z). The durability while shipping was tested by giving a harmonic load of $2 g_n$ for 15 minutes in three orthogonal directions (x, y , and z). The frequencies for each range are 10 Hz to 21 Hz, and 22 Hz to 33 Hz. The result of all tests indicated that RPM complies wit

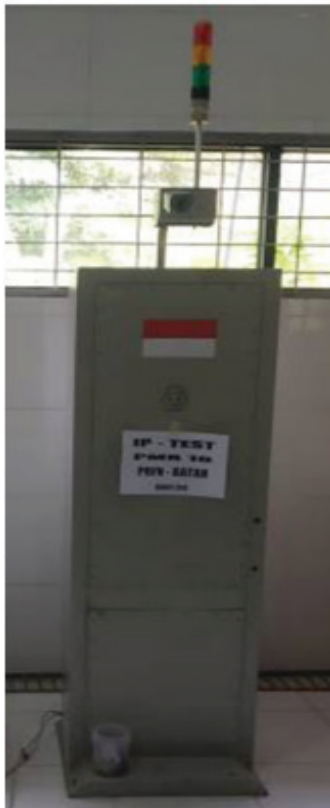
This RPM was designed for vehicles with a maximum height of 220 cm and the detection zone is height 220 cm, length 62 cm, and wide 320 cm. The configuration of the RPM can be described in the picture below:

Figure 1. The Configuration of RPM [4]

RPM was made from scintillator plastic NaI(Tl) Sodium Iodide crystal detectors and followed the requirement in IAEA-TECDOC-1312. The NaI(Tl) detector has a high ability to detect gamma-ray radiation and was integrated with a multichannel analyzer (MCA). The complete basic design and specification have been described in the previous research by other researchers [9].

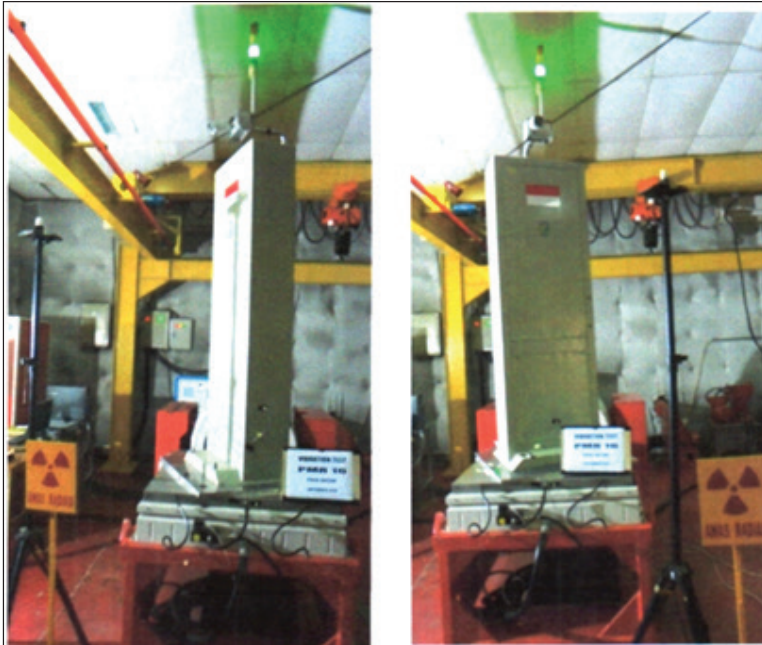
Figure 3. Test Set Up – Vibration (X-axis) Left, and (Y-axis) Right

The equipment used for the vibration test was a Vibrator combo system (LDS / Bruel & Kjaer) with V850-440 HBT900C models. For accelerating used Bruel & Kjaer Accelerometer, 4508 models. The temperature and humidity were constant.

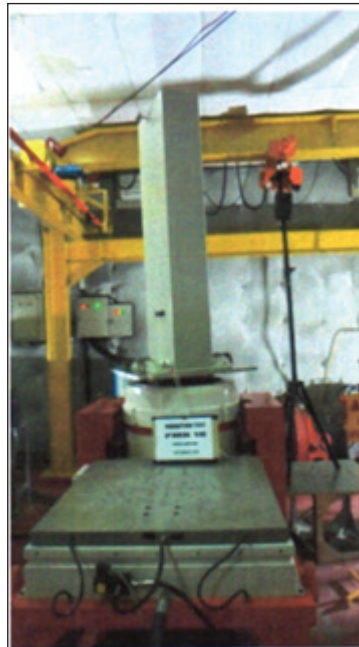
Figure 4. Test Set Up – Vibration (Z-axis)

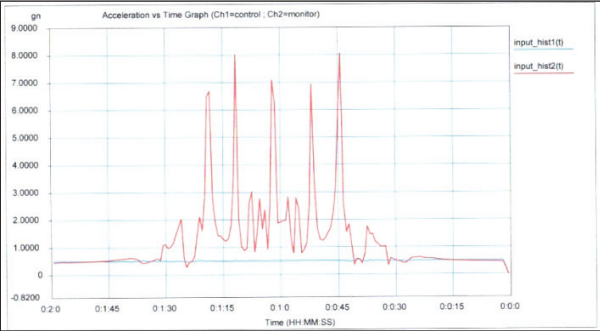
Figure 5b. Acceleration vs Time Graph (y-axis)

The test was conducted with half-sine mechanical shock for all the directions. From the result of the test in Fig 5a and 5c, we can conclude that in the x and y-axis RPM was vibrated throughout the testing process. In the x-axis, there were two high peaks with g_n ±2,9000 and ±2,5500 while in the y-axis there were 5 high peaks with g_n ±6,5000; 8,000,0 and 7,0000.

The peak indicated the amplitude/ displacement of the wave. It means that RPM moving and displace caused by accelerated vibration. The trend in the x and y-axis was quite similar but with a different impact on RPM based on the amplitude.

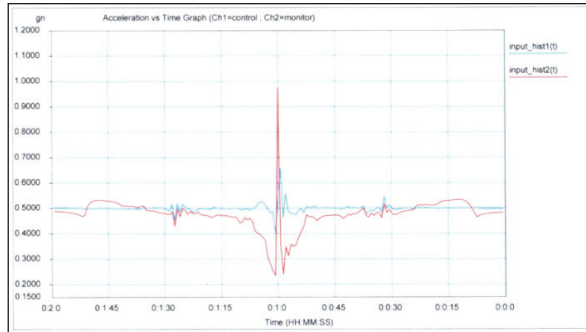
Figure 5c. Acceleration vs Time Graph (z-axis)

The trend of the graph on the z-axis was different from the x and y-axis. It was because the vibration tends to up and down in the z-axis. From Fig 6c we could conclude that only one peak was indicated. The highest peak happened after 1 minute with g_n ±0,9750.

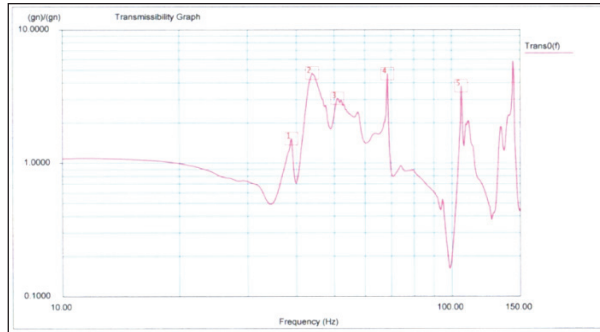
Figure 7a. Transmissibility Graph (x-axis)

The transmissibility test was also conducted and documented in Figure 7a, 7b, and 7c. The harmonic load for the test was determined from the first peak shown in Fig. 5a, 5b, and 5c. The resonance frequency of the three directions were x-axis = 68 Hz, y-axis = 39 Hz, z-axis = 142 Hz.

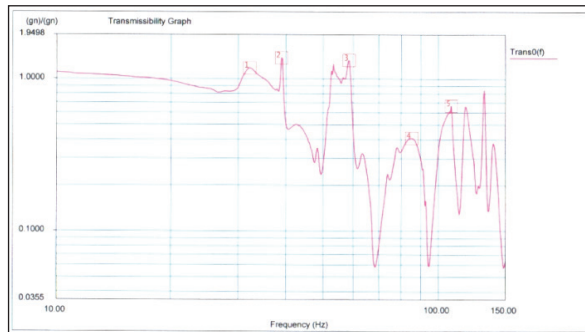
Figure 7b. Transmissibility Graph (y-axis)

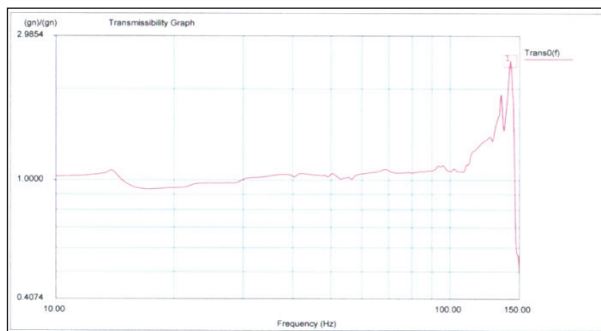
Figure 7c. Transmissibility graph (y-axis)

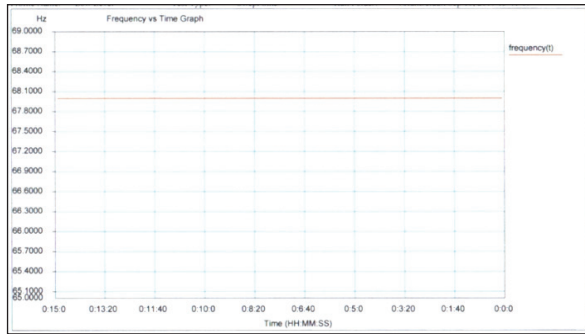
Figure 9a. Endurance Test – Frequency vs Time Graph (x-axis)

Due to the mechanical resonance was found in the test, the geometric exposure was conducted by endurance test for each frequency at each orthogonal direction. The result can be seen in Fig. 9a, 9b, and 9c.

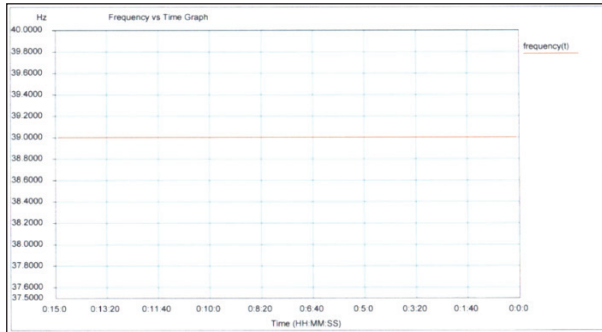
Figure 9b. Endurance Test – Frequency vs Time Graph (y-axis)
